Manhole Inspection Summary

Manhole # S39GG_042MH

Insp Date: **3/28/07 3:21 PM**

Location Address: **1324 HILLMAN ST**

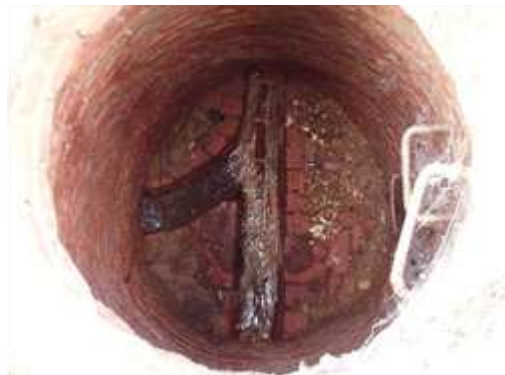
Top View

Corroded steps. Evidence of surcharge - Bench debris.

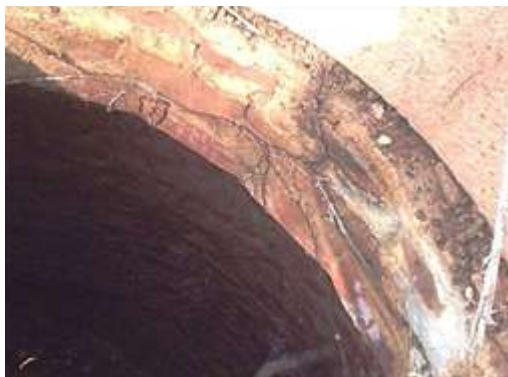
Defect

Frame leaks. Frame offset. Adjustment root intrusion, deterioration and infiltration.

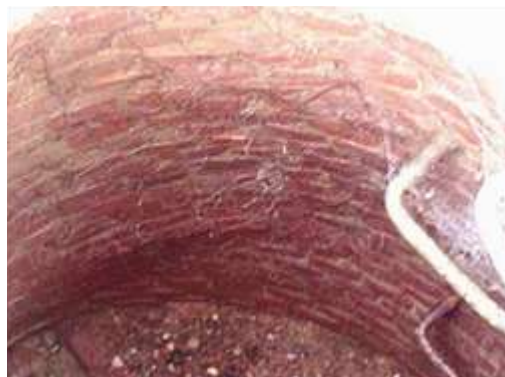
Defect

Adjustment, Corbel and Barrel root intrusion and infiltration.

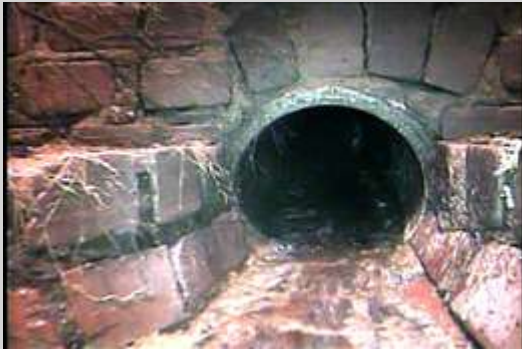
8 in. Circular Gravity Sewer Pipe Out @ 12 O'Clock

Channel deterioration. Barrel and Bench root intrusion.

Infiltration: **None** Pipe Seal Cond: **Roots**

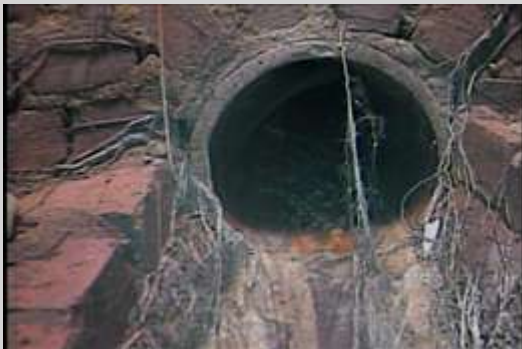
8 in. Circular Gravity Sewer Pipe In @ 6 O'Clock

Channel and Barrel root intrusion. Barrel deterioration.

Infiltration: **None** Pipe Seal Cond: **Roots**

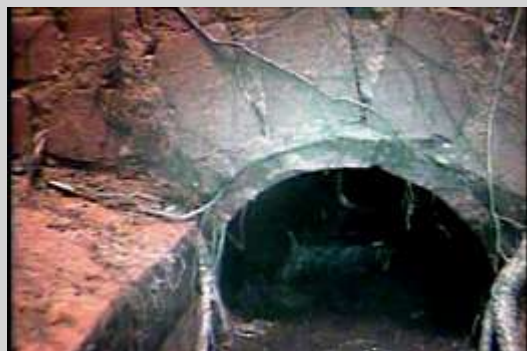
Pipe In @ 9 O'Clock

Barrel deterioration and root intrusion.

Infiltration: **Evidence** Pipe Seal Cond: **Roots**
